Battery Damage Caused by Unqualified Installers

Introduction

An electrical contractor damaged jars during installation resulting in delayed leaks surfacing after new battery and battery building was turned over to plant operations.

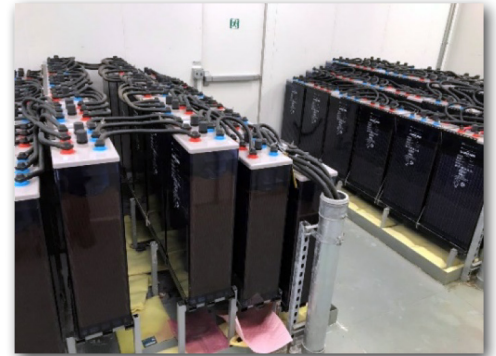
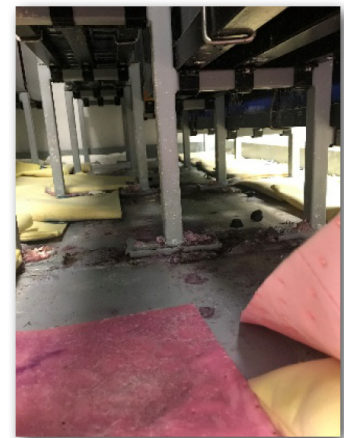
- The leaking cells were being filled with distilled water as the electrolyte leaked out. Over time all electrolyte in the leaking cells had been replaced with distilled water. The measured specific gravity of those cells was 1.001. As a result, the battery would provide little to no usable energy if called upon to support the load.
- The leaking electrolyte had caused corrosion of the battery rack and the metal floor beneath it.
- In addition, the electrolyte was leaking through the floor of the battery room onto the concrete below the battery building. This created a safety issue for personnel walking beneath the building.

- Barricade the area under the battery room due to leaking electrolyte
- Jumper out and remove leaking cells
- Neutralize, repair, and repaint the floor damaged by electrolyte
- The leaking electrolyte had caused corrosion of the battery rack feet and the metal floor
- Replace the spill containment system
- Replaced damaged rack
- Replace leaking cells
- Perform a capacity test after all the corrective actions have been completed

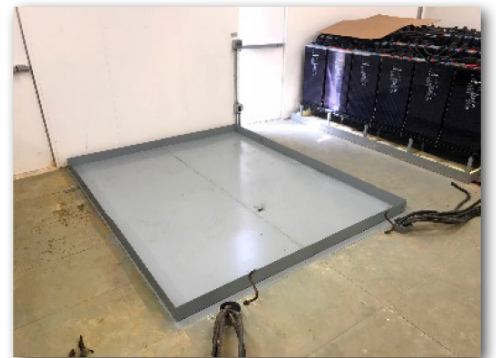
The customer followed our recommendations and had us remove all jars and the rack. This allowed access to the damaged floor which was repaired. A functional spill containment pan was added, and the rack and leaking cells were replaced.

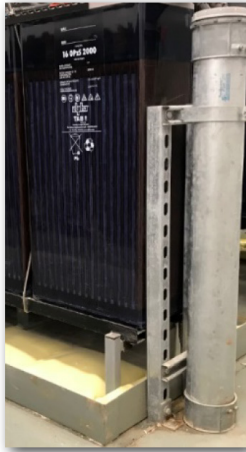
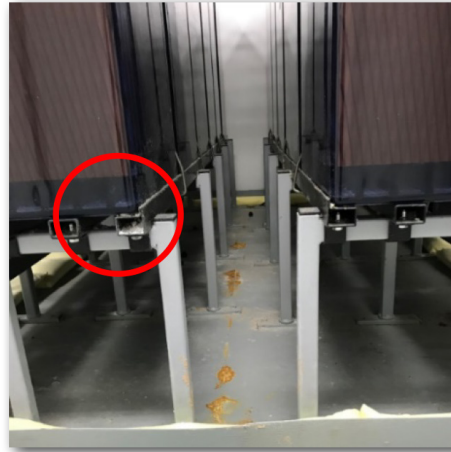
The battery installers were careless in handling the jars during installation. As shown in the photos below, the rack has a front lip. During installation, the installers rested the heavy jar on this lip, then pushed it into place. Once the front of the jar cleared the lip it dropped approximately $\frac{3}{4}$ " to rest between the front and back rails.

While the jars are designed to support the distributed weight of the cell, 330 lbs. in this case, they are not designed to support that load across the thin width of the rack lip, which occurred when the contractor pushed the jars onto the rack. Compounding the problem, additional stress was added when the battery dropped the $\frac{3}{4}$ " on to the rack rails. These actions resulted in cracks in the case allowing electrolyte to leak from the cells.

If the contractor had followed proper installation procedures, they would have placed the jars directly on the rack rail from the end of the rack, avoiding the lip, and then sliding each jar into place. This would have eliminated the stress caused by the rail lip and the drop of the jar into place. The root cause was the contractor's lack of battery knowledge and how to properly handle heavy batteries during installation.
