## Introduction

This white paper discusses the problems of post seal leaks, the factors that create them, and design considerations that will eliminate post seal leaks in most situations.

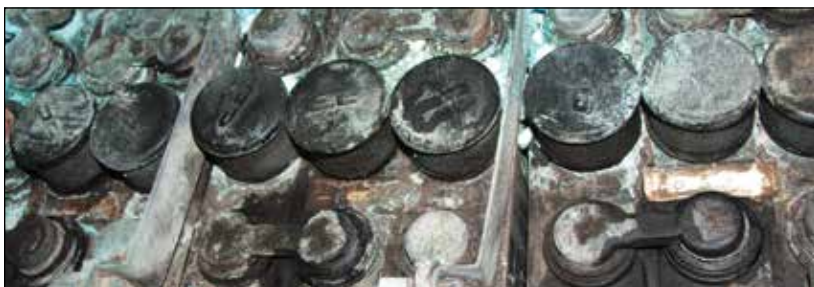
Battery post seals are designed to prevent the loss or escape of electrolyte from cells. The chemical properties of the electrolyte can cause corrosion and degradation to the electro-mechanical integrity of terminals and inter-cell connectors (**Figure 1**). Even the smallest amounts of corrosion can increase the internal resistance from one cell to another and affect the performance of the entire battery system.

**Figure 1:** Excessive corrosion due to seal leak

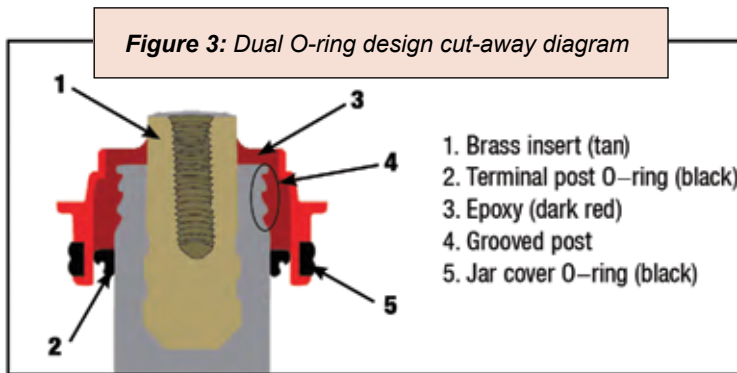
A dual O-ring system (elements two and five in **Figure 3**) adds a second seal around the outside of the cap that adds additional protection from electrolyte escaping the cell. This allows the cover seal to expand and contract along with modest variations in internal temperature caused by overcharging / overuse, or high external temperatures while the internal seal prevents electrolyte from escaping up the post into the electrical connections. This added flexibility restricts the corrosive electrolyte from penetrating the seal and harming the battery. In this way, the double O-ring prevents corrosion and reduces the prevalence of problems associated with post seal failures on single O-ring design types.

Grooved battery posts have a unique shape on the top of the terminal that secures inside the cap, securing the two components together (element 4 in **Figure 3**). The grooved posts also help prevent any shifting that may happen as a result of temperature changes. By providing a lip to hold the cap in place, there is also less of a chance that the seal will loosen, exposing voids in the seal.
